Repair of Utility Cuts Using Interlocking Concrete Pavers

Tech Spec 6—Reinstatement of Interlocking Concrete Pavements, published by the Interlocking Concrete Pavement Institute, provides step-by-step guidance for repairs to vehicular and pedestrian pavements made with concrete pavers. A unique, experimental variation of the techniques in this technical bulletin is demonstrated in London, Ontario, where repairs to utility cuts in asphalt are made with interlocking concrete pavers (6). The local gas company normally reinstates cut pavement in the winter with cold patch asphalt after making repairs to gas lines. In the spring, the cold patch is typically removed and hot mix asphalt is placed in the openings.

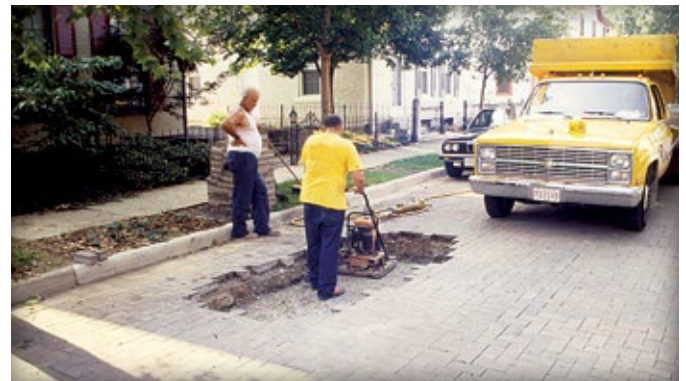
Figure 3. Compaction of the base

Figures 2, 3, 4, 5 and 6 show the process of repair and illustrate the continuity of the paver surface after it is completed. The reinstated units are knitted into existing ones through the interlocking paving pattern and sand filled joints. Besides providing a pavement surface without cuts, the joints distribute loads by

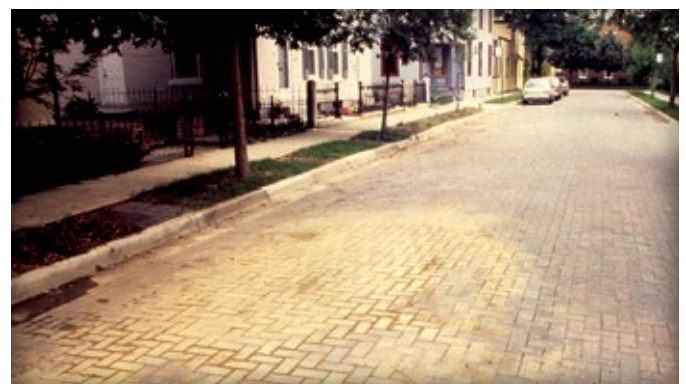
Figure 5. The final paver surface is continuous. There are no cuts or damage to the pavement.

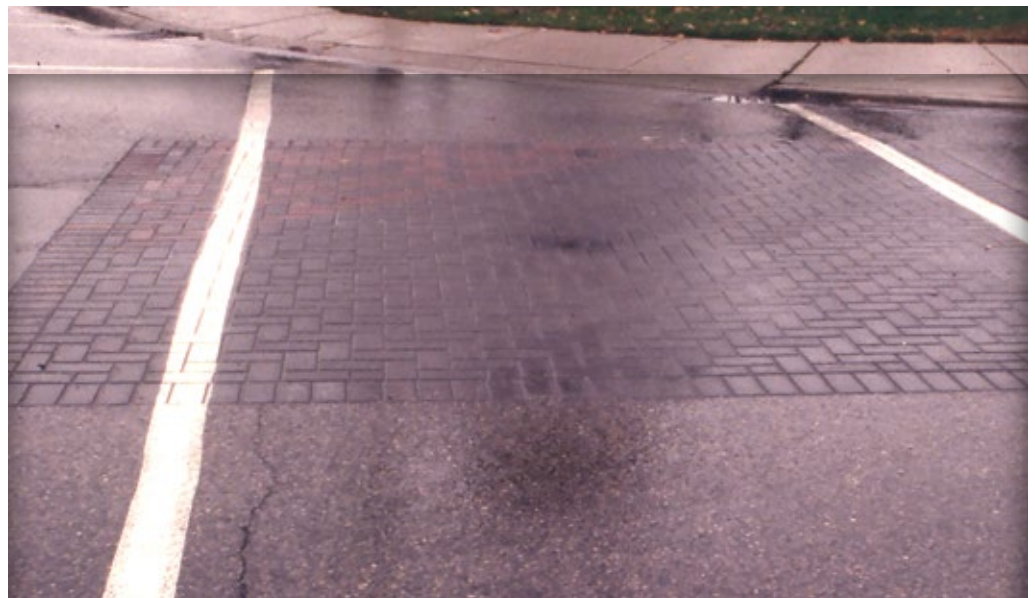
Figure 13. Concrete pavers in utility cuts can be painted as any other pavement.

Spread, sweep and compact sand into the joints. The joint sand is typically finer than the bedding sand, and should conform to the grading requirements of ASTM C 144 (11) or CSA A179 (10). The joints must be completely full of sand after compaction. Remove excess sand and other debris. The pavers may be painted with the same lane, traffic, or crosswalk markings as any other concrete pavements (Figure 13).
